Manhole Inspection Summary

Manhole # S03UU1018MH

Location Address: **3607 GLEN AVE**

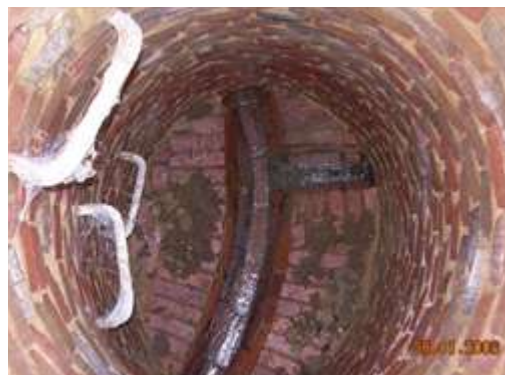
Top View

Adjustment and Barrel infiltration.
Evidence of surcharge - Bench debris.

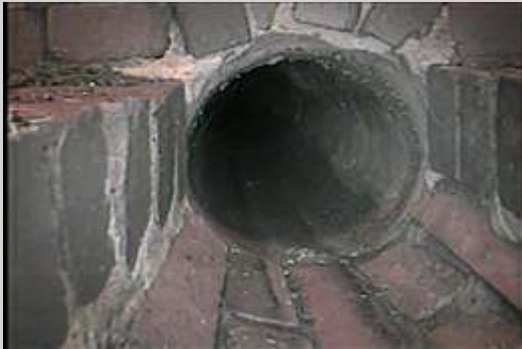
8 in. Circular Gravity Sewer Pipe Out @ 12 O'Clock

Invert Depth: **7.55** (ft.) Flow Characteristics: **Slow**

Infiltration: **Evidence** Pipe Seal Cond: **Unknown**

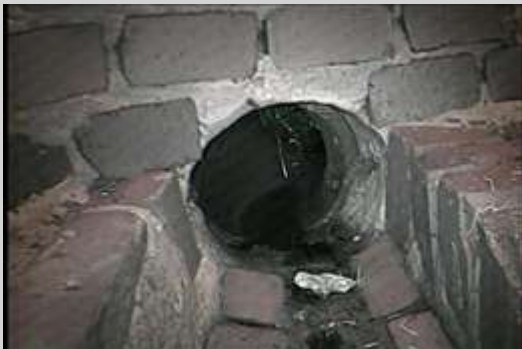
8 in. Circular Gravity Sewer Pipe In @ 3 O'Clock

Deposits: ☐ None ☒ **Mud** ☐ Sludge ☒ **Debris** ☒ **Grease**

Silt Depth: **0** (in.) Deposits Extent: **Light**

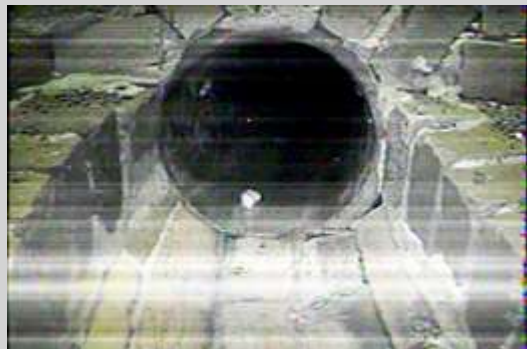
8 in. Circular Gravity Sewer

Invert Depth: **7.18** (ft.) Flow Characteristics: **Slow**

Infiltration: **Evidence**
